The Steele Plan Phase 1

**Drainage
Restoration
and
Improvement**

Revised September 7, 2021

Petal, North Downtown Area

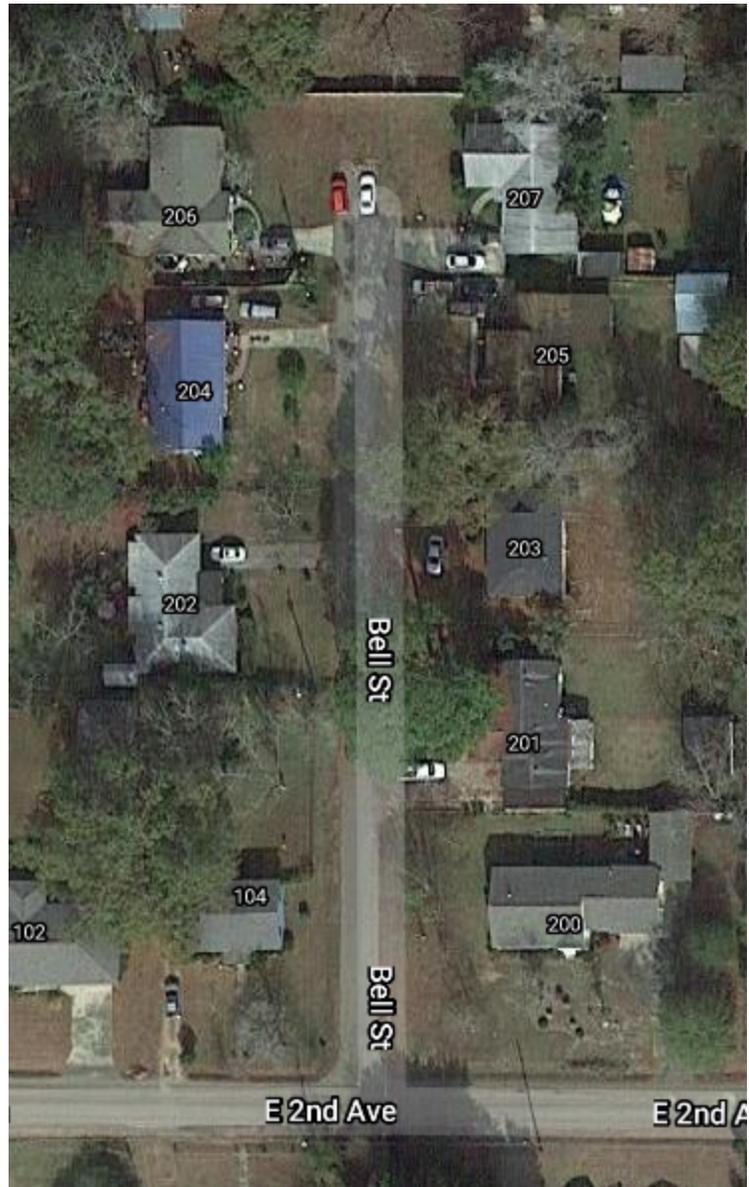
Work on Bell St is about to begin 9/6/21. This work is said by locals to include the digging of ditches on both sides of the street and the replacement of an undetermined number of culverts. Ward 1 Alderman was not consulted for this project. This project is not as urgent as the Steele plan's prioritized list. This work should be done eventually, but in logical order. This work, with what is known, is likely to make things worse unless E Second Ave and N Main also receive substantial work. Although the cost is unknown, it is clear that this is currently one of the most complicated and expensive projects in this plan. This work will not help the area as a whole. No reason or methodology was given for the selection of this project.

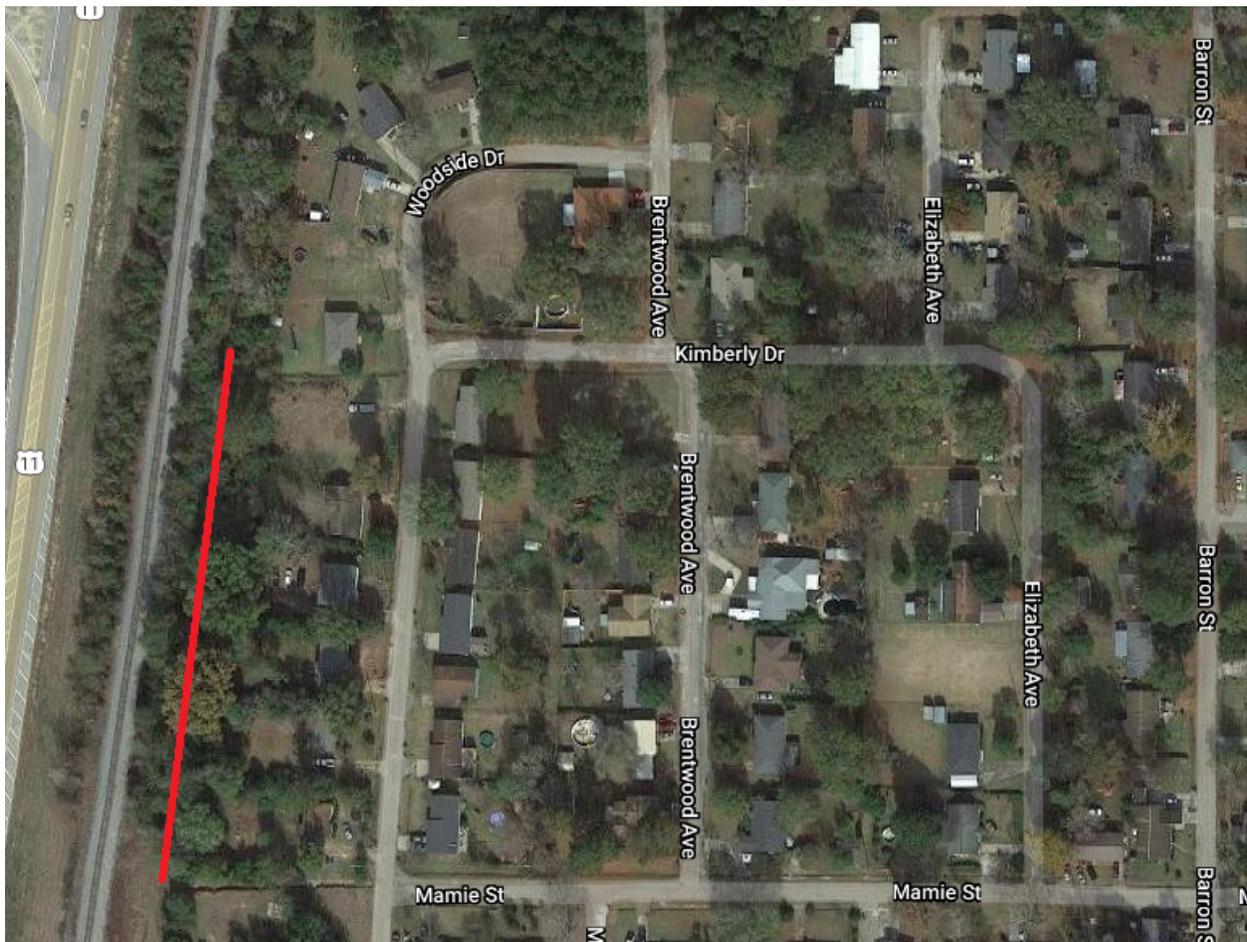
On 7/21/21 work was started behind the houses on Woodside Dr. The work done will not have a positive effect on any homes or businesses and may potentially make matters worse if it is to continue. The major flaw in this work is that it does not follow objective 2 (see 1.2). Digging from a major water exit to the problem area would be beneficial and is desperately needed. However, this work is starting at an “upstream” location and water has no place to flow out to because the downstream path is clogged. Starting this work “upstream”, will create a massive retention ditch that cannot flow out. The red line below marks the location of the new work. This area is addressed by the Steele plan below (marked as the green line and given 4th highest priority).

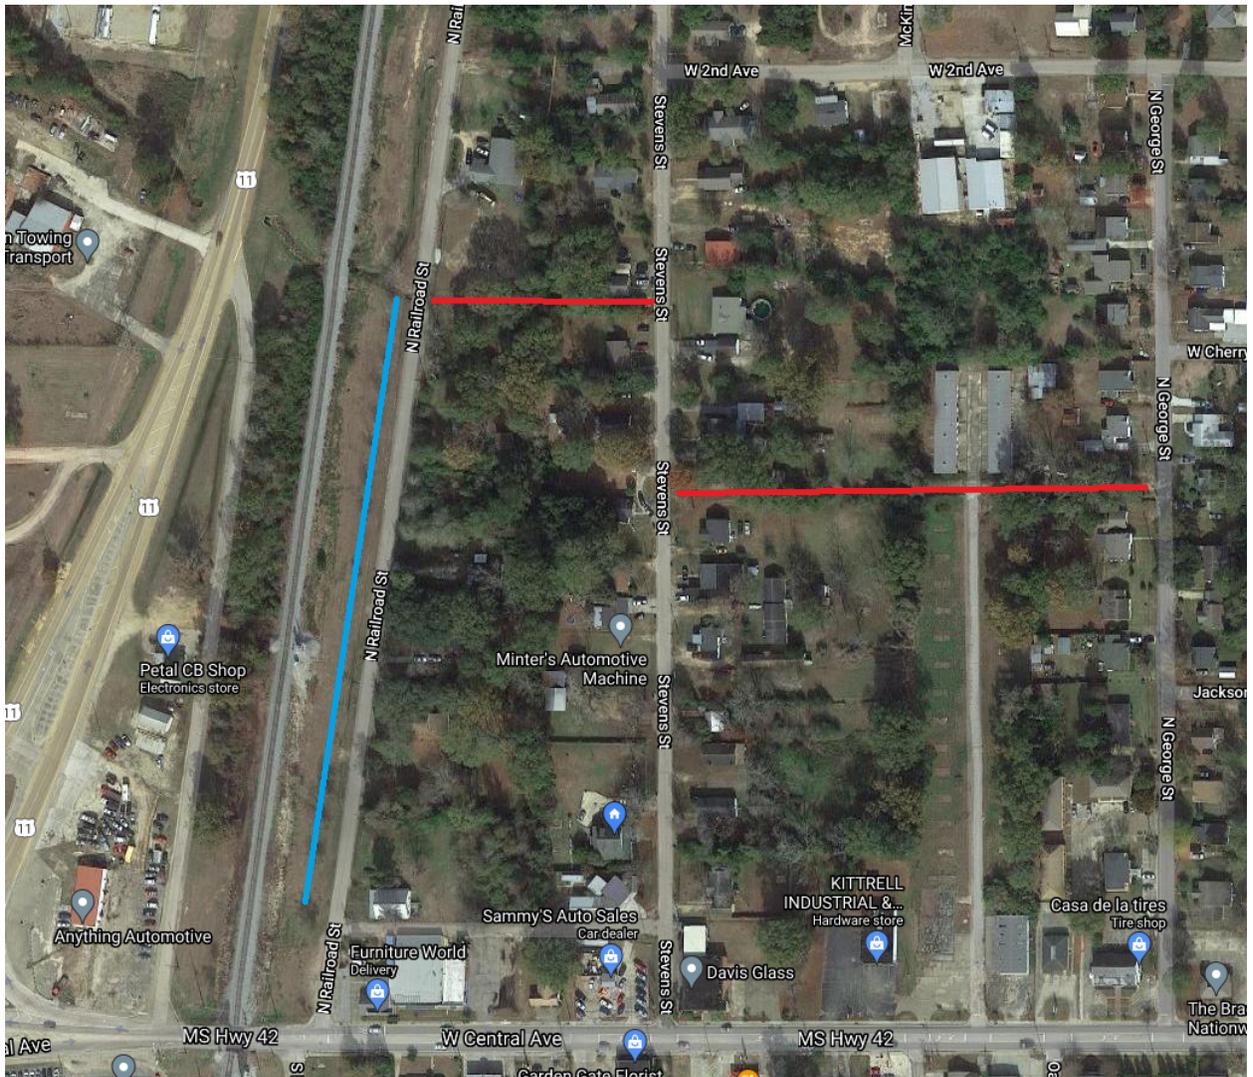
On 8/20/21 work was completed on N Railroad St. The work was done on the train side of the tracks and will not have a positive effect on any homes or businesses. This work will not help the area as a whole. No reason or methodology was given for the selection of this project. This project has the potential to slow the flow of water exiting residential areas. The blue line marked below shows the criticized work while the red lines show work that was requested by the elected alderman for the area. The work did need to get done eventually, however, it was clearly not a priority and should have been done much later in the process.

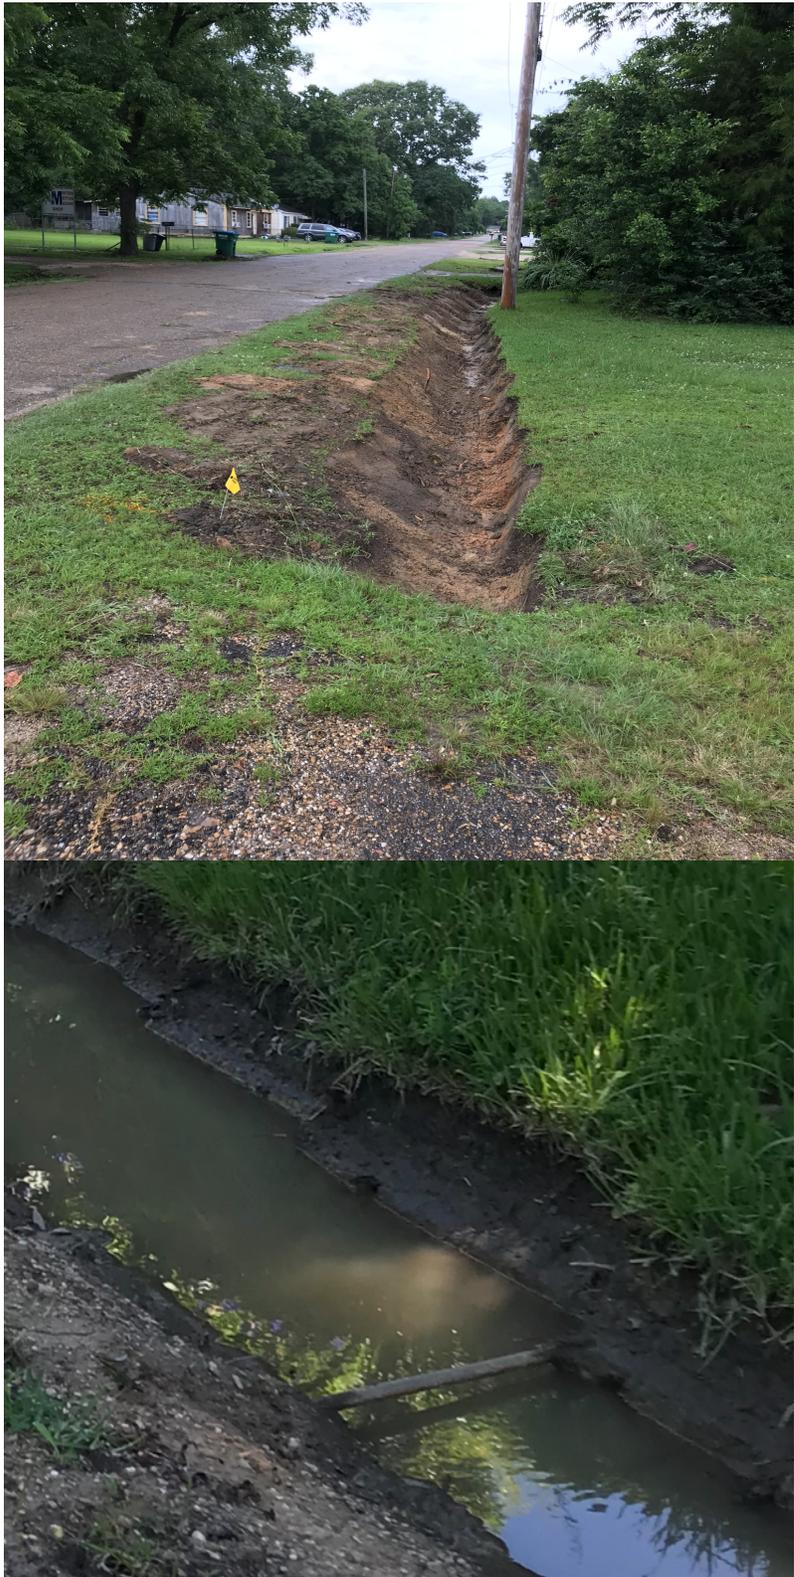
On 6/2/20 work was completed on Stevens St. The work did not have a positive effect on any homes or businesses and did make the problem worse. Several ditches were dug, on both sides of the street, but did not have any outlet. These ditches have no flow and hold water for days after a rain. Although the work was started by a citizen complaint, that complaint was retracted and work was requested to stop, before it was started, by the original complantant. The author of this plan tried to have the work stopped, with the support of all owners of all affected properties. He even went so far as to stand in front of a bulldozer to halt the work. However, the work was done while residents were at work later in the week. The work was started in an "upstream position" and therefore is unable to drain out. The work did not follow local ordinance in regard to slope and is now impossible to mow. A water line was exposed and remains exposed (right bottom photo). This work demonstrates a disconnect between decision making and residents of the area and is unacceptable.

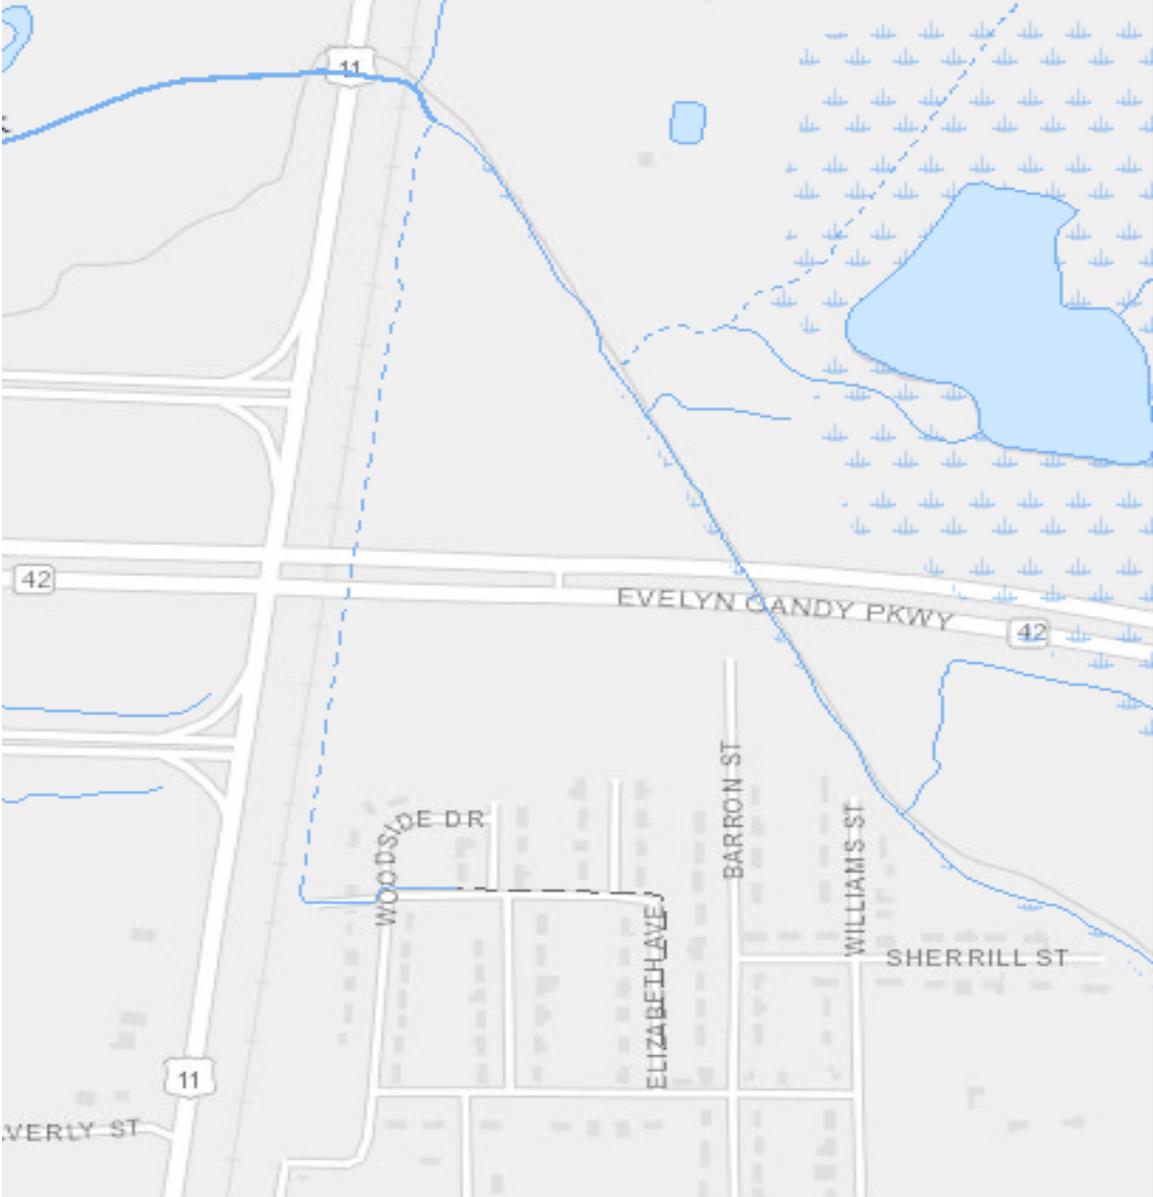
A further inspection of these above artifacts and firsthand exploration revealed that this designated area currently only has two major water exits working; through the railroad tracks to the west and Greens Creek. However, the third major water exit, as shown below, is not currently working. Repairing this old ditch would provide relief to those near Woodside Dr and also create a much needed third major water exit that would ultimately help the entire zone. This project is part of the Steel plan and named the green line. It is the 4th highest priority.

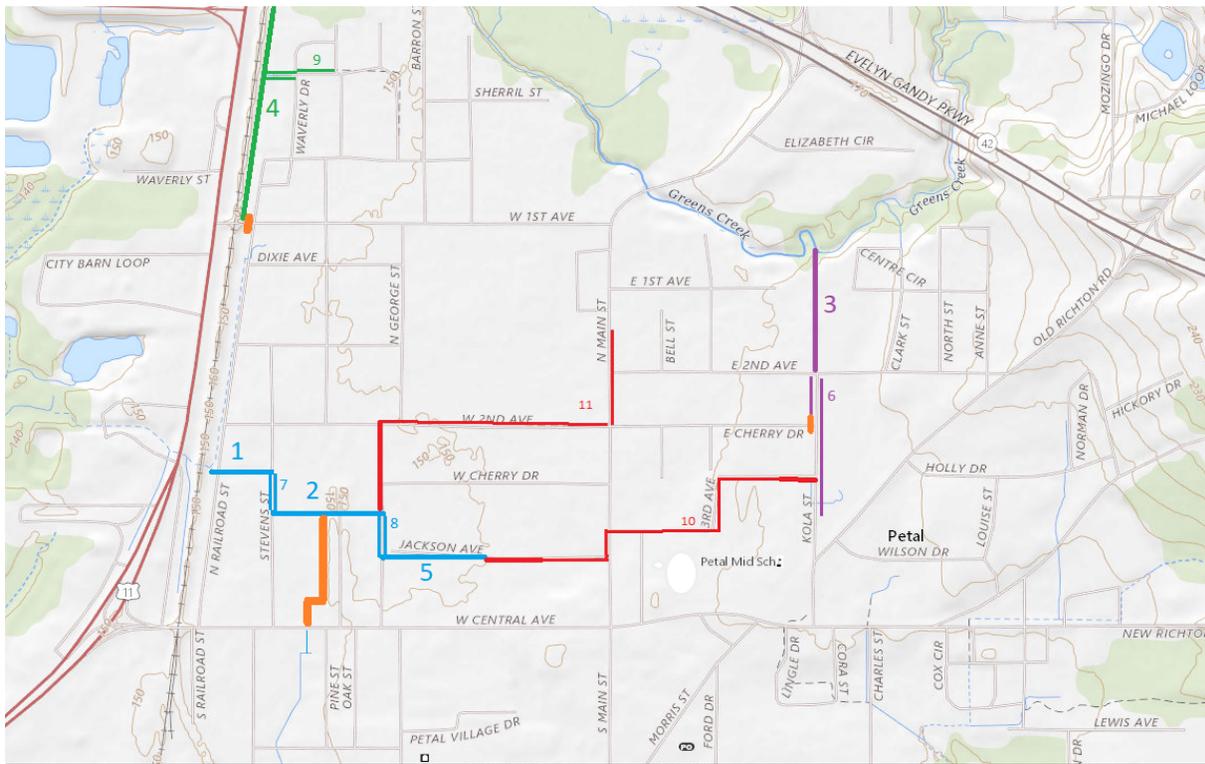
1 The blue line is the lowest part of the area, and it handles more flow than any other ditch, making it the first priority. Cleaning and maintaining these ditches will have positive impacts as far east as Old Richton Rd and as far north as the Gandy. This line is one of two main ways water can get out of this area at this time.

2 These are three major projects in planning. The first is a culvert under 1st st, the second is a culvert under E Cherry, and the last is a connection from the BlueLine to a pre existing culvert that passes under central. This will provide another much needed way for water to make it to the river. Currently there are only two outlets. I am waiting for the city engineer to finish a report.

3 This line will continue under the Gandy and connect into Greens Creek. This was functional at one time and shows up on old maps, but has not been maintained and needs to be redug at this point. This is only the first step for this area, but also the most important. This will provide yet another new way for water to escape the area.

4 These are old underground drainage pipes and drains that have filled with dirt. They are no longer working as they should and need to be cleaned out and repaired. They will also need to be properly connected into the existing infrastructure.

5 This is one of the two ways water can drain out of this area and it is in need of cleaning. The surrounding ditches will also need cleaning and some minor work to make sure they flow out to Greens Creek.

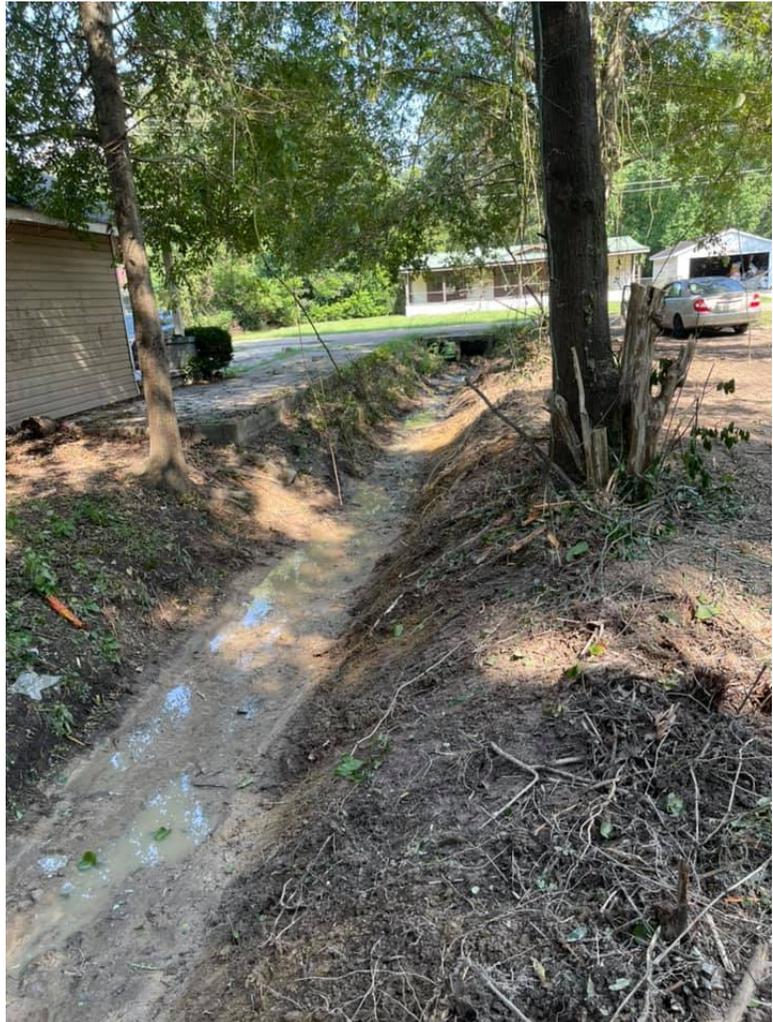
Section 1 (Blue line)

The first section of the blue line (marked 1), as shown above, has been completed.

This was one of the more difficult ditches to clean.

Completed 9/1/21

It took two days to complete.
