The Steele Plan Phase 1

**Drainage
Restoration
and
Improvement**

Revised September 7, 2021

Petal, North Downtown Area

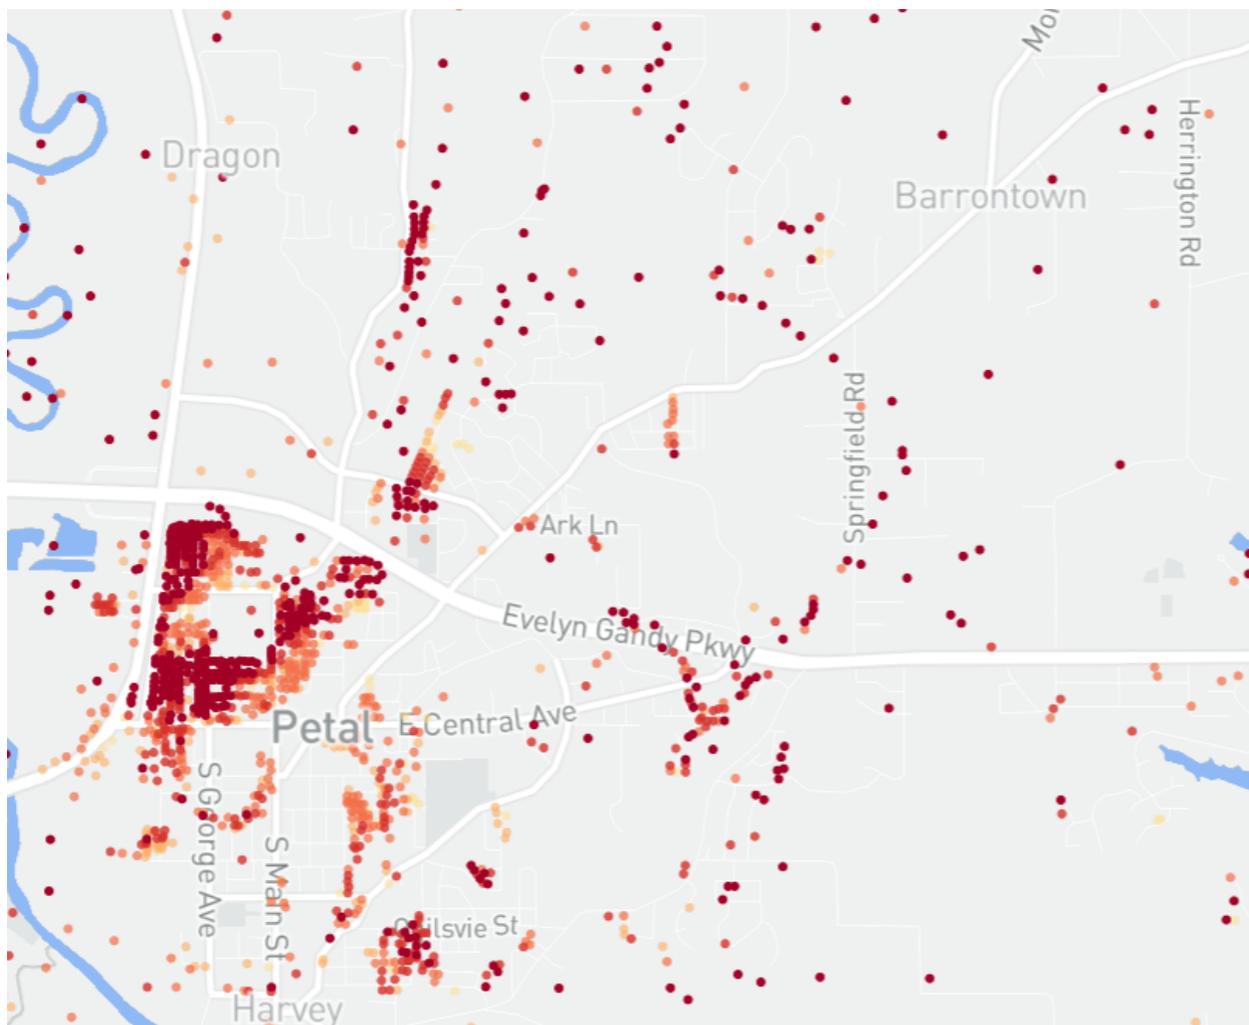
The designated area suffers from the most extreme flooding in the city as shown below (https://floodfactor.com/city/petal-mississippi/2856800_fsid).

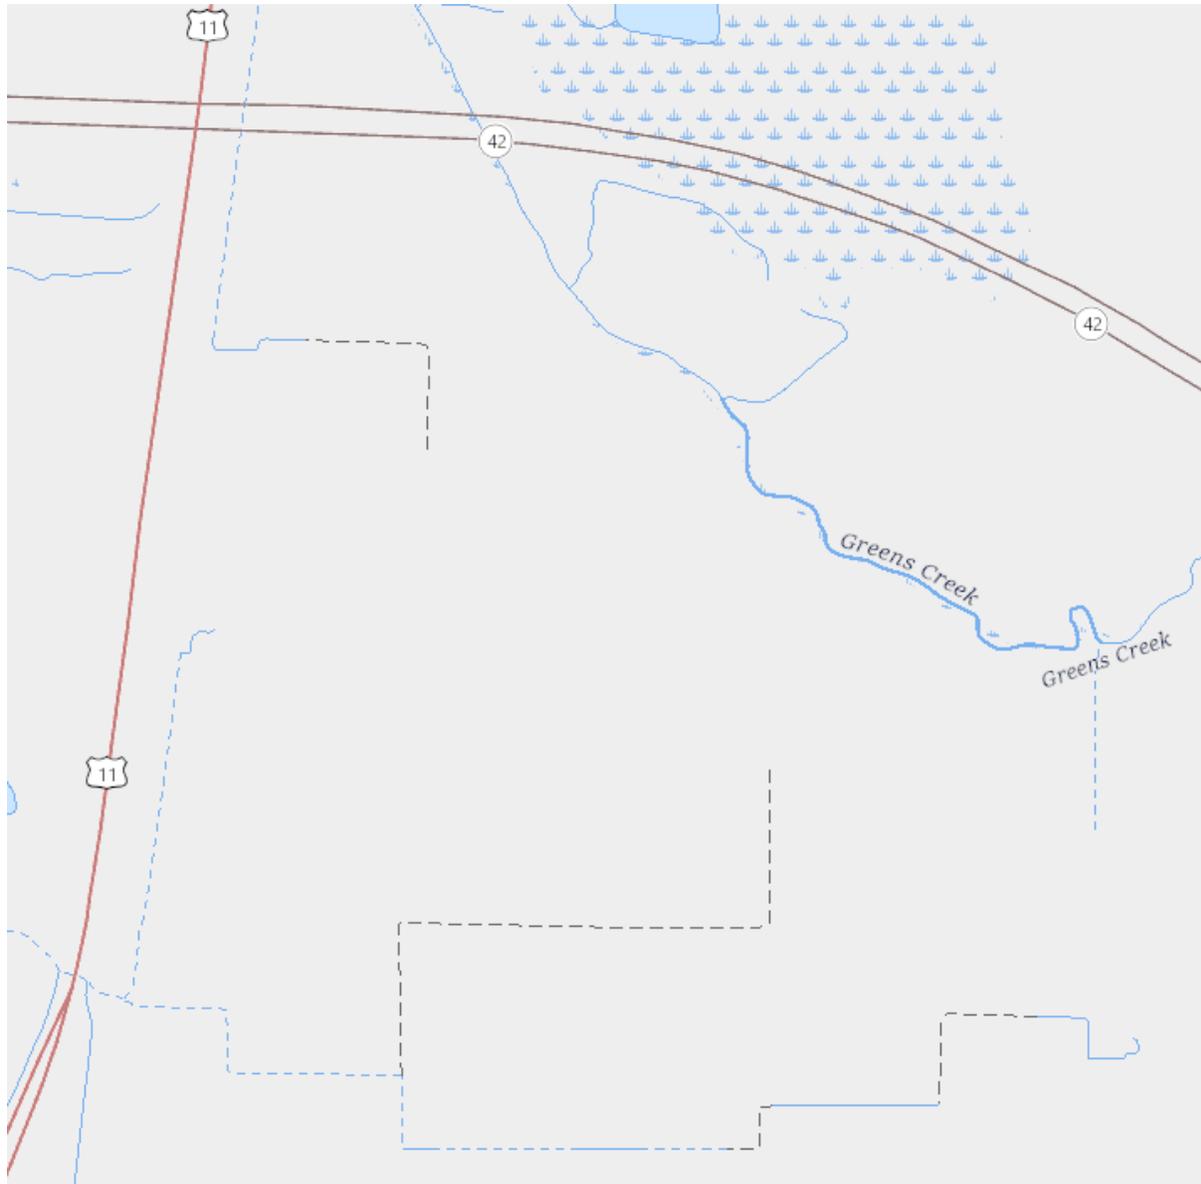
Input was gathered from residents, FEMA charts and maps, U.S. Geological Survey maps, video during rain storms, personal data gathering, weather reports and records, as well as newspaper articles. During this study, an old drainage infrastructure was found. The best representation of this old system was found in the USGS mapping system as shown below.

This is the first phase of the Steele Plan. The restoration of this old drainage system will have a major positive impact on the entire area. Some of these lines need repairs and modification while others need very little, but in the first phase we must focus on cleaning and reactivating these lines in order to see how the water flows to better determine where repairs and modifications should take place.

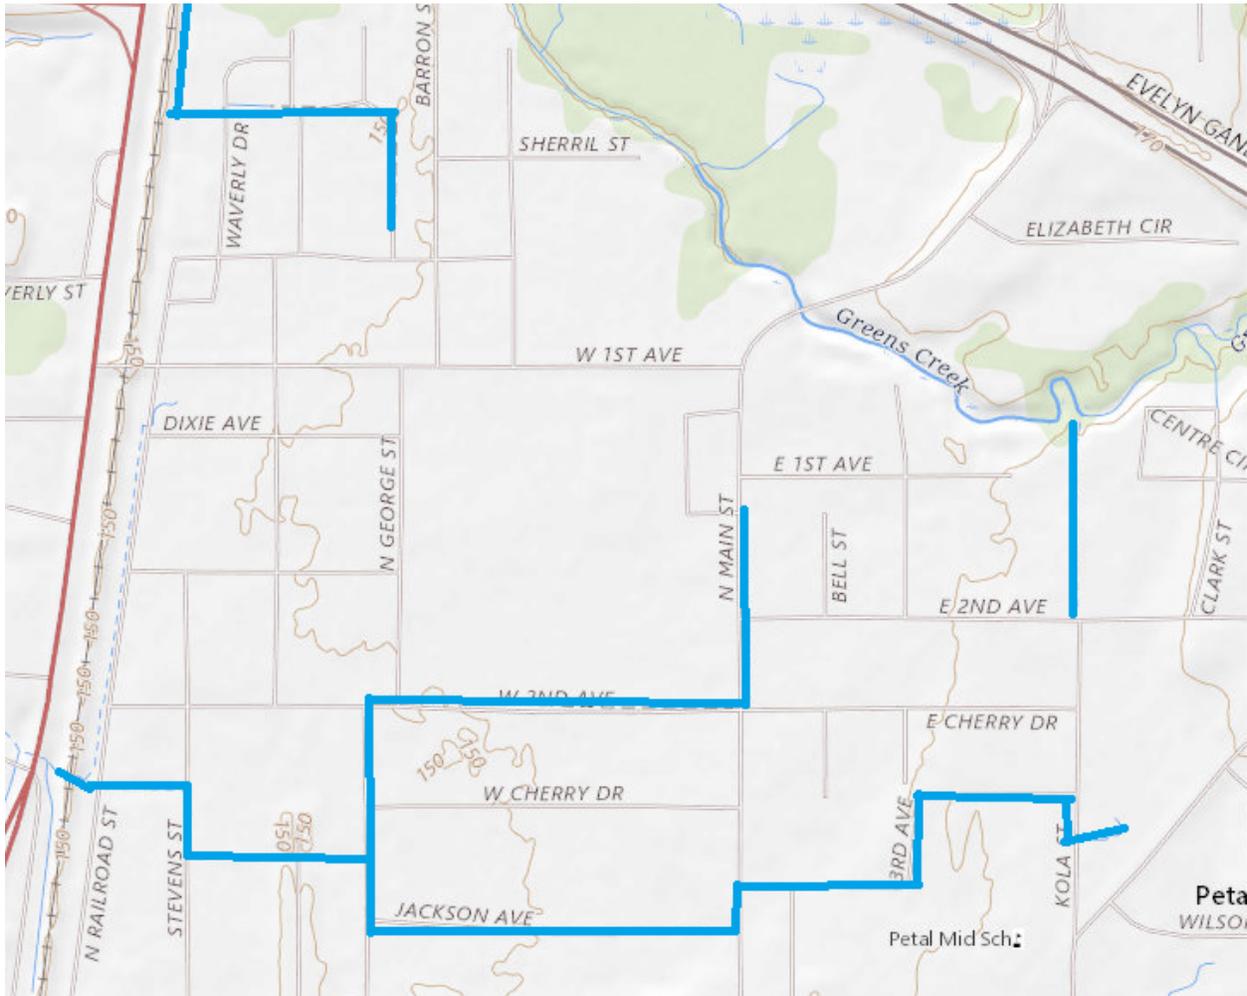
To help understand where these forgotten waterways are in relation to our streets we can overlay them on a road map as seen in the bottom map.

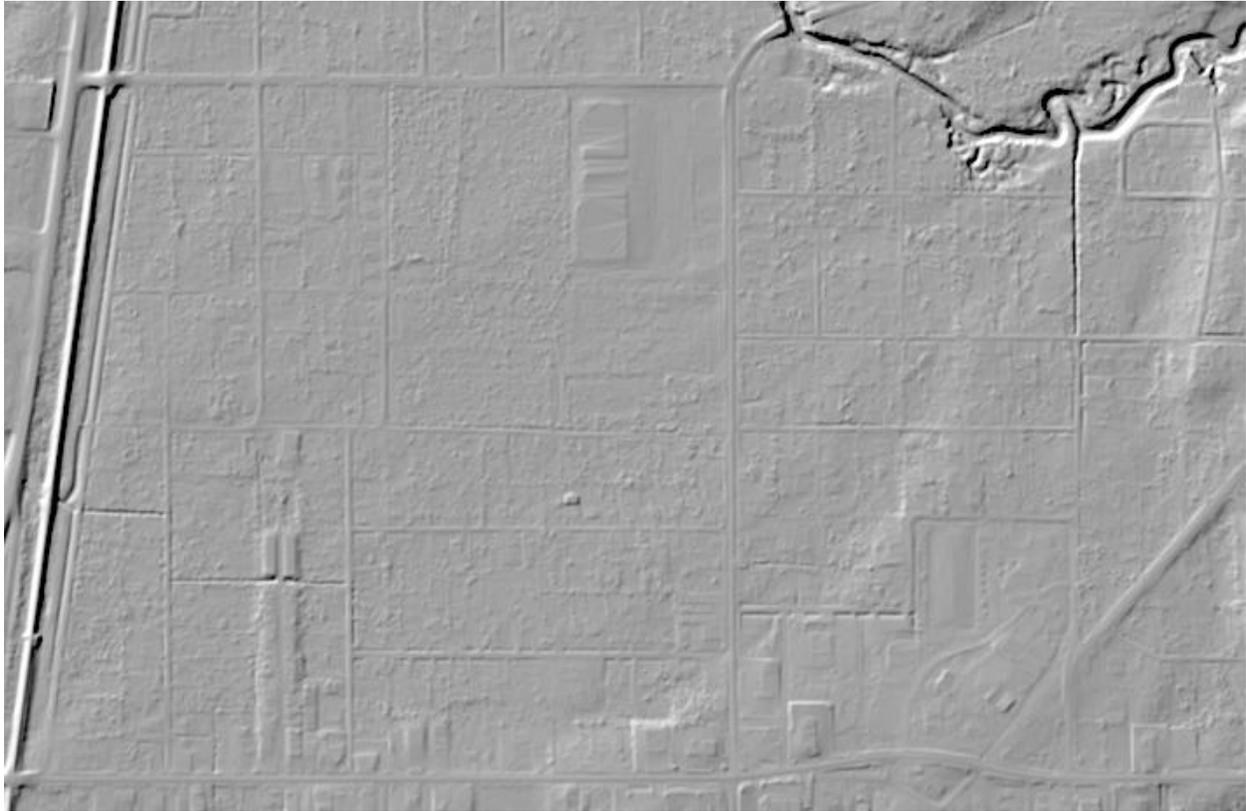
However, a look at USGS mapping again shows us that our priorities need to be very deliberate and calculated. The below images show surface contours and where our most important ditches are. The two horizontal lines in the South West corner and the deep vertical line in the north East corner are our main lines that feed directly into the only working major water exits.

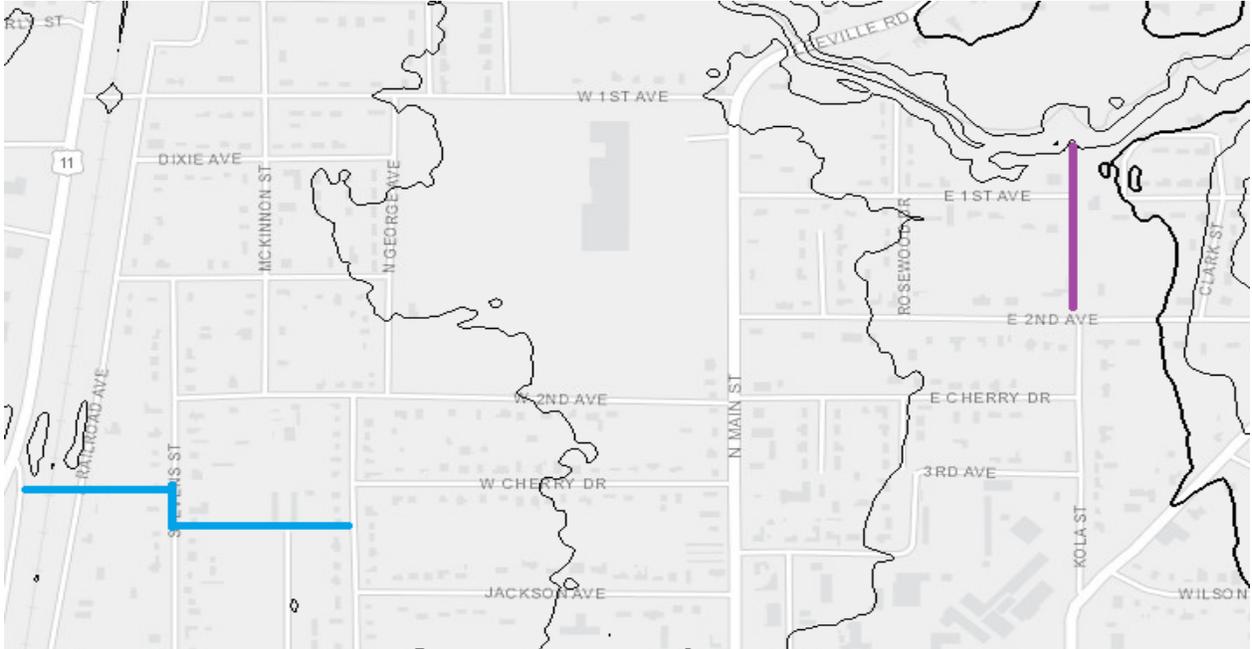
Based on the elevation of these two major water exits, a determination was made that the lower one likely “moves” more water. Below is a topographical map showing a slope to the west. This ranked these two lines as first and second priority, as they are extremely overgrown with vegetation, with the currently clogged Woodside Dr being second.

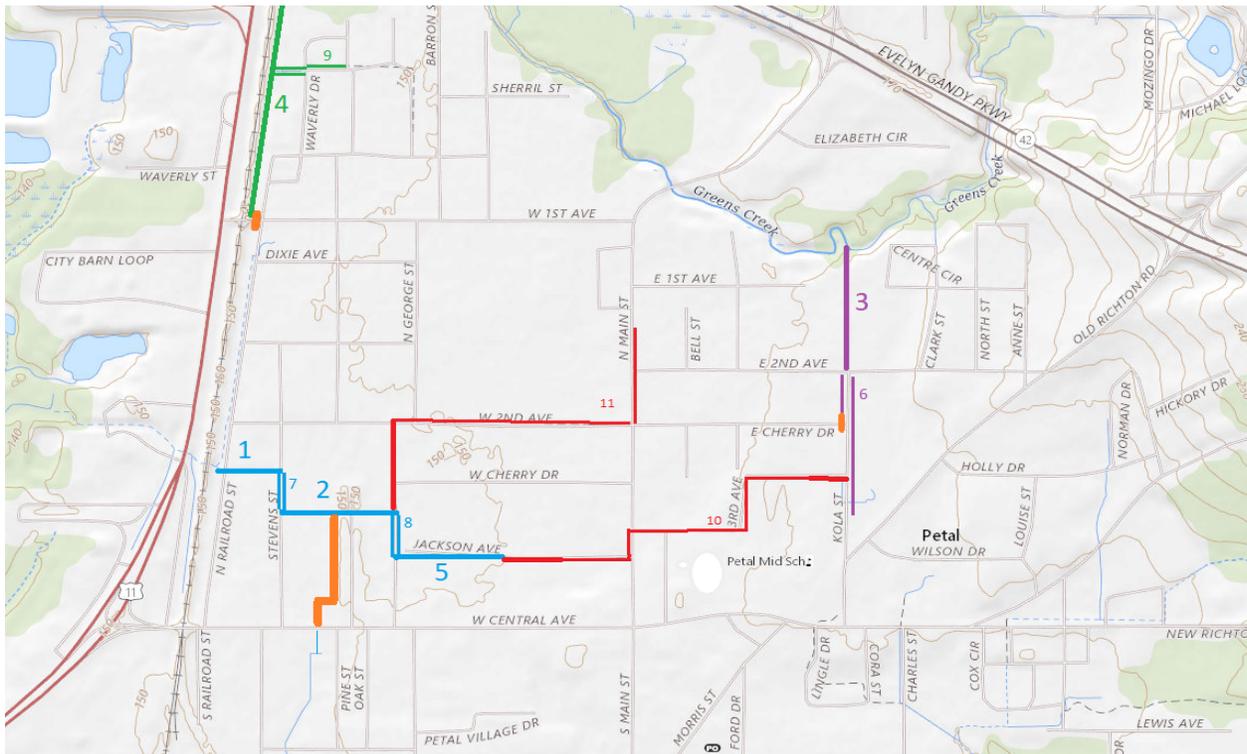
From this point a map was made that incorporated other projects and a prioritization order to clean ditches.
